IMPACT OF GOLF COURSES ON WATER QUALITY OF BUI RIVER IN HEADWATER CATCHMENT

SUMMARY

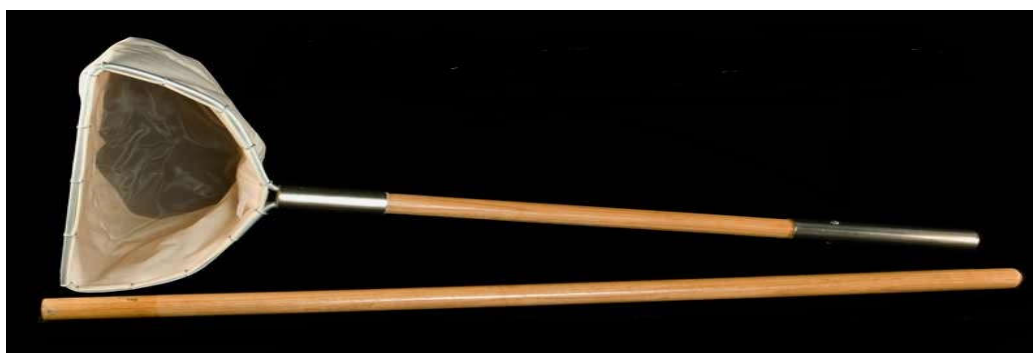
Figure 2.3. Pond net to collect macroinvertebrate samples

Macroinvertebrate samples were collected by pond net after taking water samples. Invertebrate samples were collected by the method of Nguyen Xuan Quynh et al (2004) by pond net then all of the specimens were preserved in 70% alcohol (fig. 2.3).

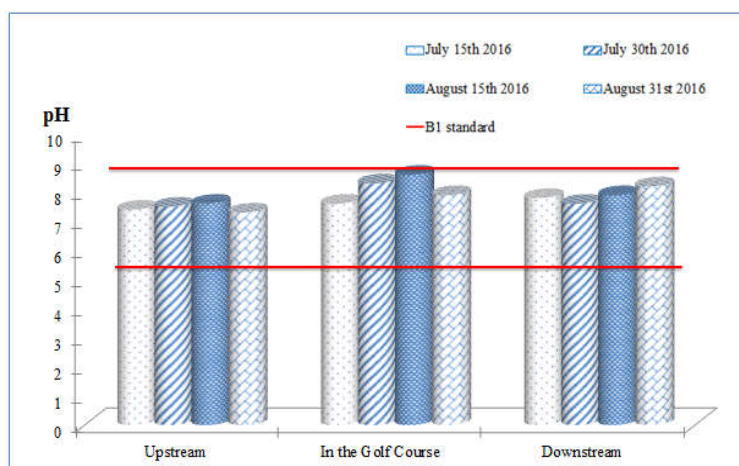
Figure 3.1. pH fluctuation in four periods at three different locations

pH levels of water quality in Bui river during four periods and different locations change from 7.3 to 8.6 (fig. 3.1). This fluctuation is small and all values belong to allowable limit of standard B1 (for aquatic life).

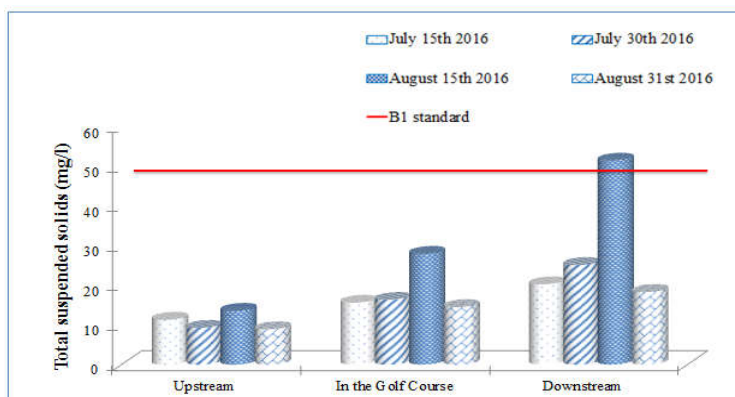
Figure 3.2. The amount of TSS in four periods at three locations

Total suspended solids of Bui river water increased significantly from upstream to downstream, especially after rainy day, the concentration exceeded the B1 limit (fig. 3.2).

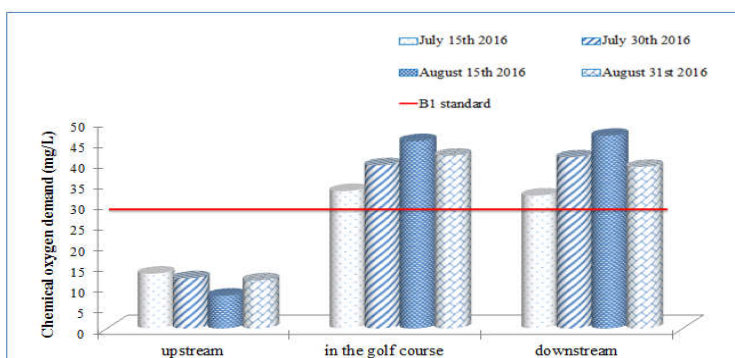
Figure 3.3. COD concentration in four periods at three different locations

The concentrations of COD are increased remarkably from the upstream to downstream

and exceeded B1 limit in the location inside the golf course and downstream after turf grass was applied fertilizers and pesticides (fig. 3.4). With these values, water quality in downstream and in the stream passed through the golf course is not acceptable for agriculture and aquaculture.

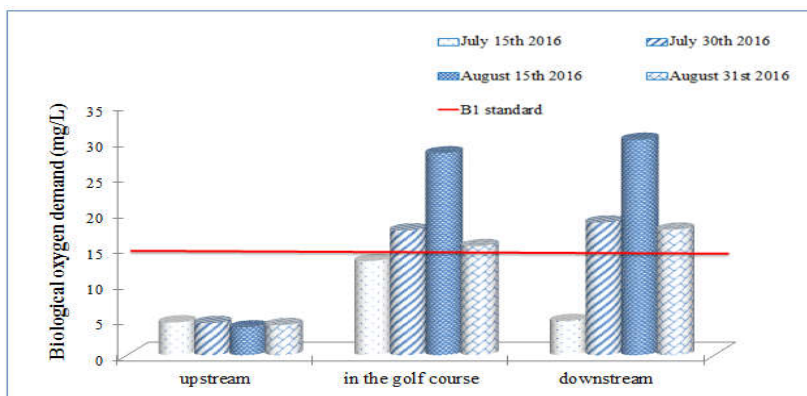
Figure 3.4. Values for BOD in four periods at three different locations

The concentration of BOD increased dramatically from upstream to downstream

along Bui river (fig. 3.4). In rainy day, it exceeded B1 standard with the highest values, which is more than 30 mg/l.

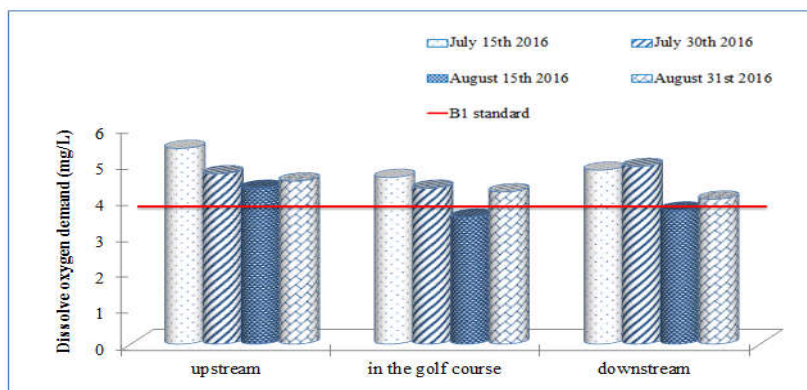
Figure 3.5. DO level of Bui river in 4 periods at 3 locations

Similar to COD and BOD concentration, DO is decreased gradually when golf course used pesticides and fertilizers in rainy day, this concentration lies below B1 standard, which can cause stressful to aquatic ecology (fig. 3.5).

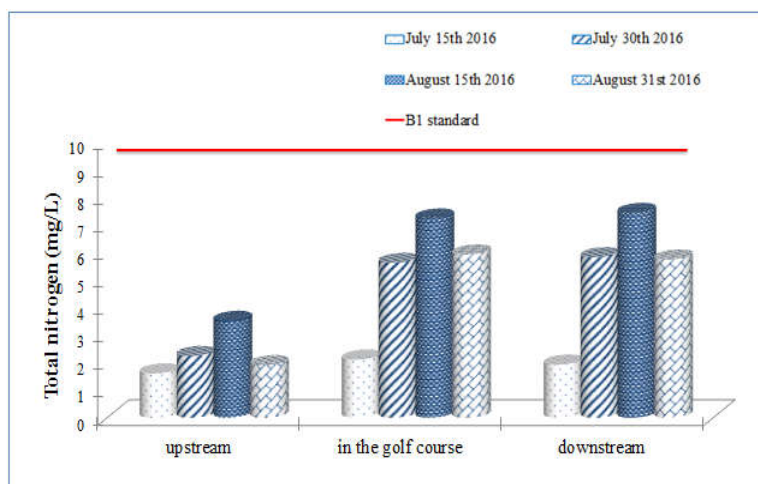
Figure 3.6. Total nitrogen of Bui river in 4 periods at 3 locations

Unlike other concentrations, although the values of total nitrogen increased significantly from upstream to downstream, especially after the golf course applied fertilizers and pesticides, it does not exceed B1 limit (fig. 3.6).

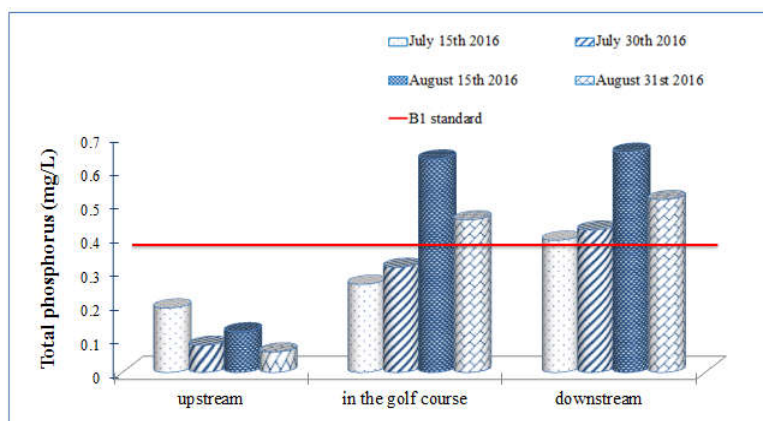
Figure 3.7. Total phosphorus of Bui river in 4 periods at 3 locations

From the figure 3.7, we can see that, two areas inside the golf course and downstream area were affected by applying fertilizers and pesticides, the concentration of phosphorus increased significantly and exceeded B1 standard.

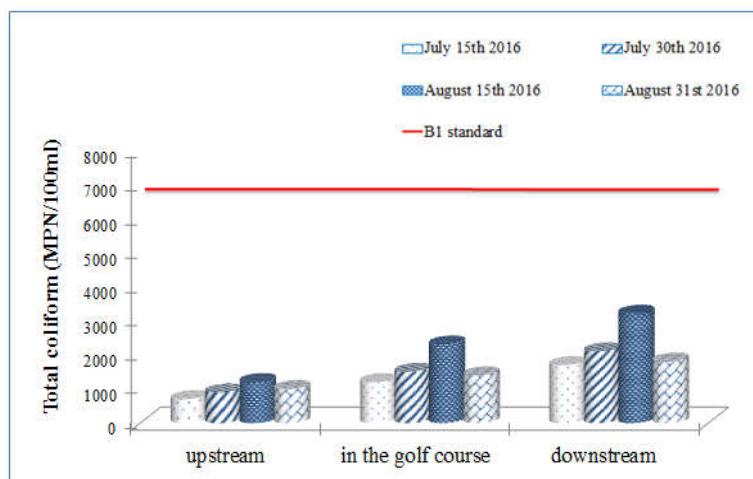
Figure 3.8. Total coliform of Bui river in 4 periods at 3 locations

The figure 3.8 below indicates the significant increase of total coliform bacteria from upstream to downstream of Bui river surface water. In general, total coliform in 4 periods at 3 locations are lower than the limits of B1 standard (which is lower than 7500 MPN/100 ml).

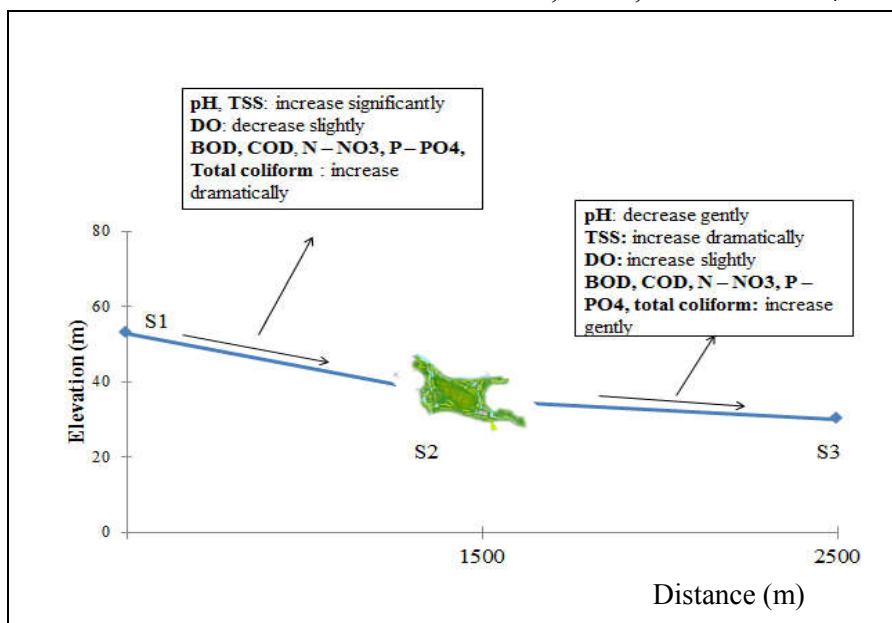
Figure 3.9. The impact of Phoenix Golf Course on water quality of Bui river from upstream to downstream

Phoenix golf course in operation and maintenance can cause increase organic waste in water and lead to a significant difference of water quality parameters from upstream to downstream (fig. 3.9). Almost physical and chemical parameter of water increased

significant from upstream (no impact) to golf course and to downstream. This suggests that golf course have changed water quality of Bui river such as physical and chemical indicators of water at the study site. More impact of golf course was showed in increasing of TSS, BOD, COD, DO and P-PO₄³⁻.

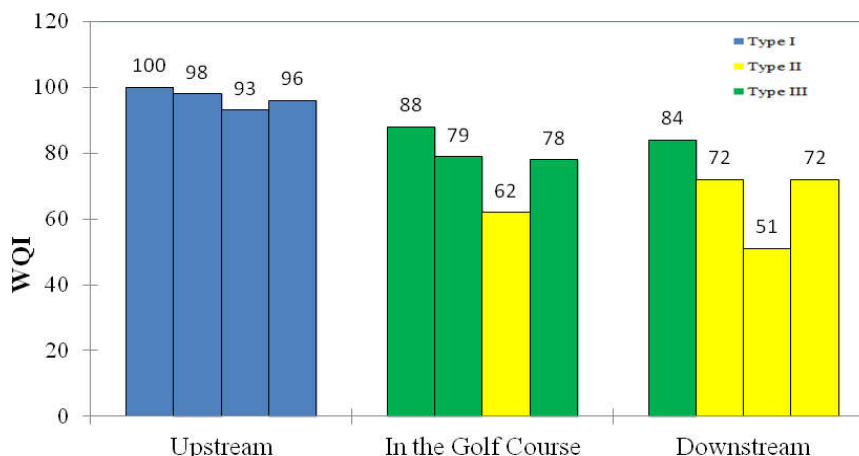
Figure 3.10. WQI values in 4 periods at 3 locations

The WQI values in four periods at three locations were different. Overall, WQI values decrease dramatically from upstream to downstream (fig. 3.10). In upstream, all WQI values belong to water type 1, range from 91 - >100: good for domestic demand (excellent). In the location of golf course, almost all values belong to water type II: used for domestic demand but need treatment or water quality is quite good; only water sample on August 15th when golf course sprayed fertilizers and pesticides in rainy day, WQI value drops to 62, which indicates for medium water quality, or water used for agricultural purposes. In downstream, almost samples have low WQI

score which belongs to water quality of type III: used for agricultural purposes, only water sample on July 15th has WQI gained in water quality of type II.

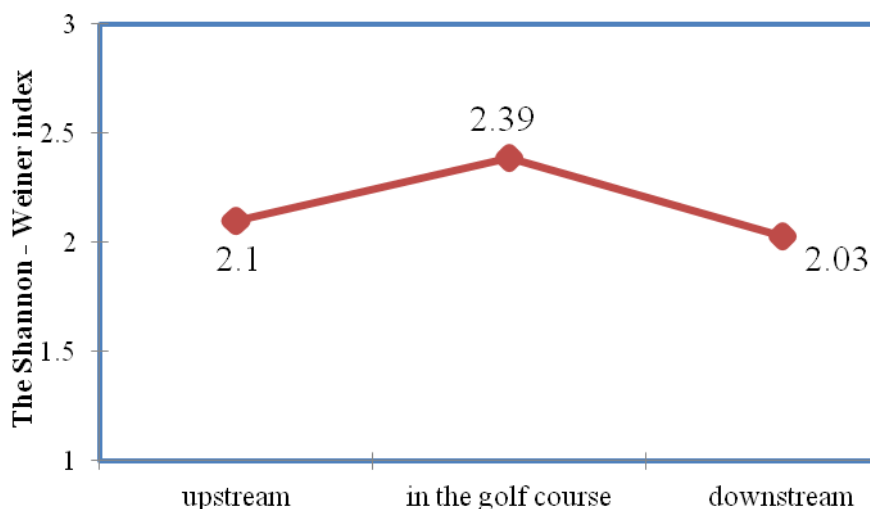
Figure 3.12. The Shannon Wiener index of diversity values at study site

According to the results of figure 3.12, although the location in golf course did not have the highest number of families, it's the location that has highest diversity value which equals to 2.39. Upstream has 2.1 score and downstream has 2.03 score. This values was not significant difference.

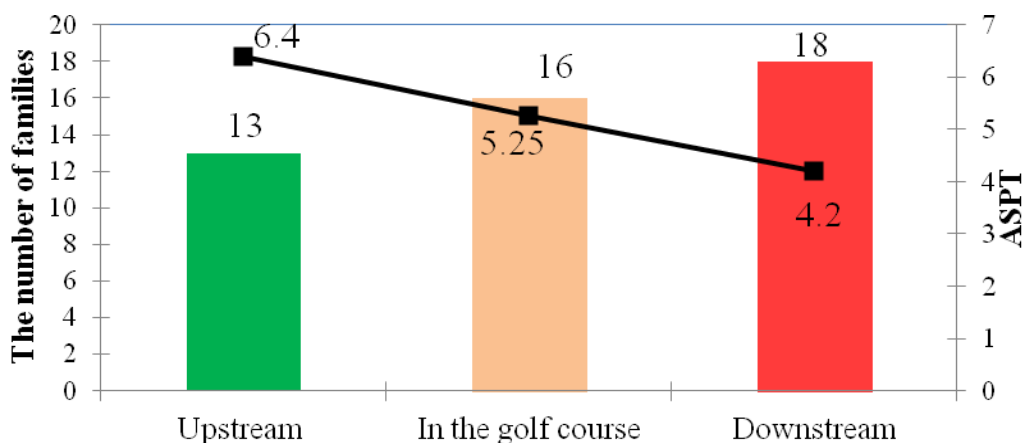
Figure 3.14. The respond of the number of families and ASPT score

Figure 3.14 indicated the respond of the number of families and ASPT score at three locations: upstream, in the stream passing though the golf course, and downstream. From the figure, we can see that, although the location in upstream has lowest number of families, it has highest ASPT score which indicates that water in this location is slightly clean. Meanwhile, sample location in the golf course has lower ASPT score while the number of families is higher. The location that has highest number of families is downstream. There are 18 families, but it has lowest ASPT score which is 4.2 (very high pollution).
